The property located at 3727 Lafayette Street (Property ID #519), was assessed for Lead Based Paint (LBP) on July 12, 2005. The house located at this address contained areas of LBP, with the highest concentration of lead detected at 19.24 milligrams / centimeters squared (mg/cm2). The condition of the paint on the house where LBP was detected was determined to be intact at the time of the assessment, and therefore no action is required at this time.

Property ID # 519 / 3727 Lafayette

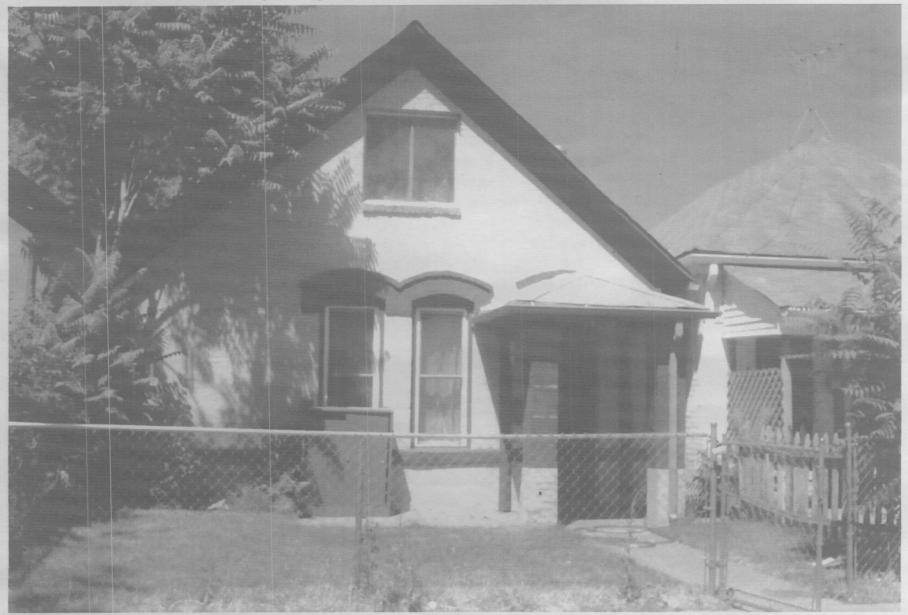
Property is lead free except for the wood & brick columns on porch, which are in good / fair condition
